CITY OF DURHAM, NORTH CAROLINA

ANNUAL SANITARY SEWER SYSTEM REPORT FY 2016-2017

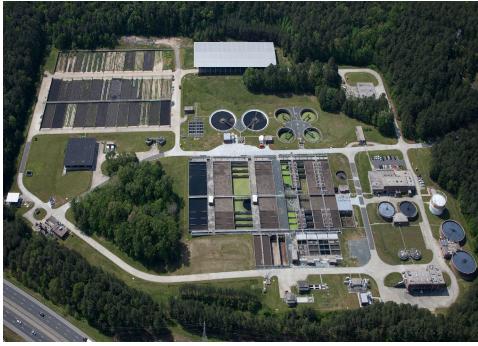
South Durham Water Reclamation Facility. The City operates two WRFs.

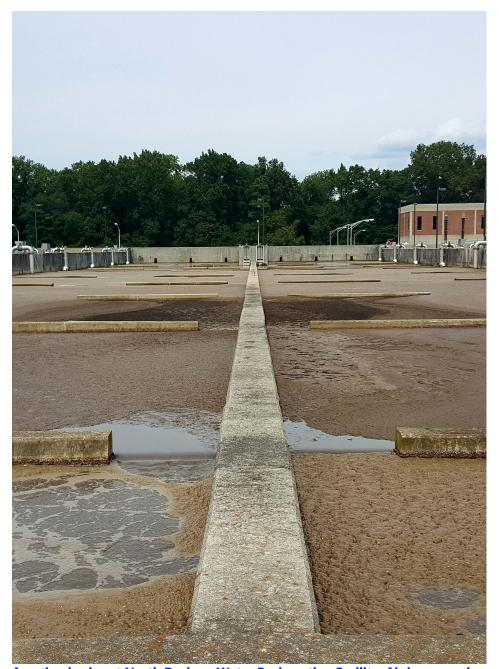
Aeration basins at North Durham Water Reclamation Facility. Air is pumped into the wastewater to help microorganisms feed on organic material.
